PRELIMINARY RESULTS OF A STUDY OF THE MORPHOLOGIC - PLANIMETRIC VARIATION OF A CENTRAL ITALY CREEK

MARCHESINI I. & FREDDUZZI A.

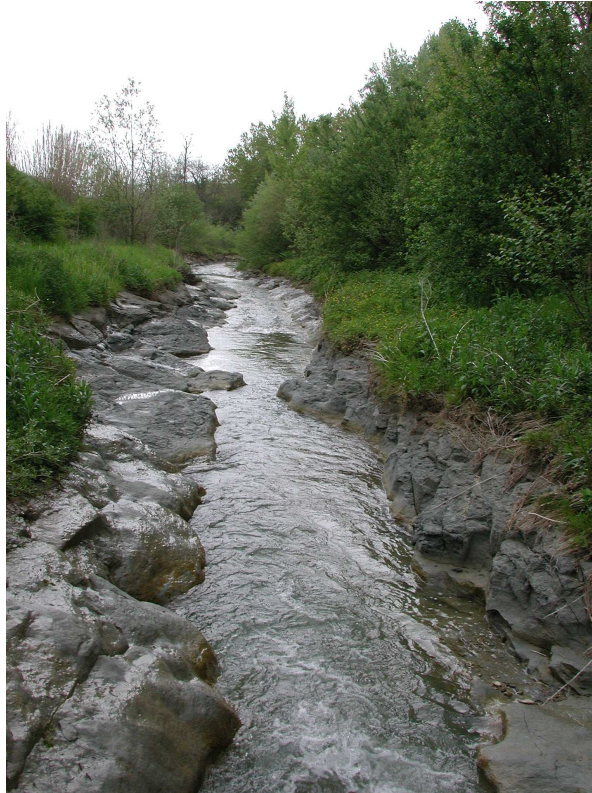
FIGURE 2.1. Creek reach extremely incised. You can note the high left banks and the outcropping of overconsolidated pliocenic clay

Field indicators of these phenomenon are: the abandonment of the alluvial plain, the presence of numerous different order terraces, the bedrock outcropping along the water course (see figure 2.1), the evidence of suspended paleo river bed, and so on. The field geomorphologic analysis, however, can show all these phenomenon, but can't quantify them.

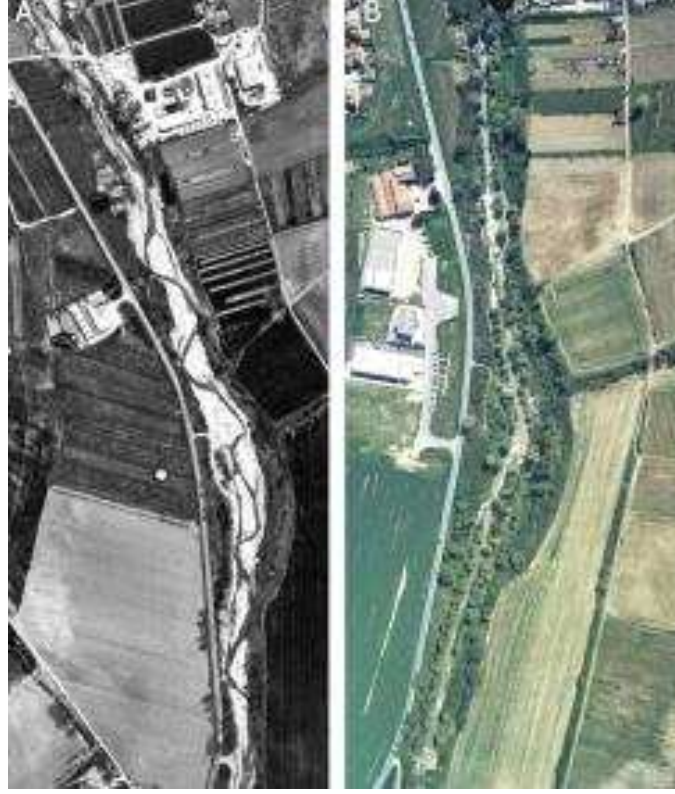
FIGURE 5.4. River bed reach showing transformation from braided to single channel morphology.

The braiding index average value was 1.31 in 1982 and became 1.03 in 2001: many longitudinal, nude, sedimentary bodies have become lateral, inactive vegetated bars (see fig. 5.4) .

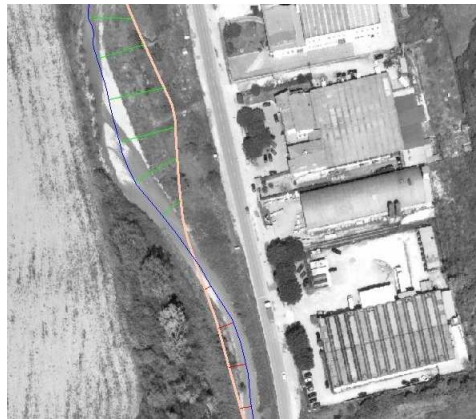
FIGURE 5.6. Bank erosion and damaging of agricultural land property: in rose the 1982 river axis path, in blue the 2001.

The results of this measure show river reaches where lateral shifts were of the order of 1.3 - 1.2 metres/years (see fig. 5.6).
